**USB LATENCY REQUIREMENTS AND
THE EFFECT OF VIDEO ADAPTER PCI
RETRY CONDITION ON MAINTAINING
USB STREAMING PIPELINES**

California State University, Sacramento
Department of Electrical and Electronic Engineering

March 20, 1997

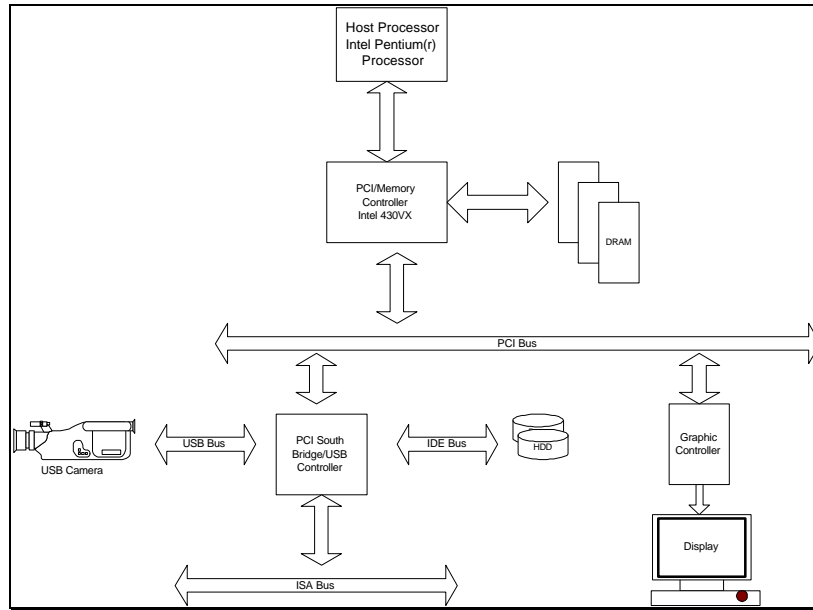
Figure 1: USB-Enhanced System Architecture

A USB camera was installed in a Pentium® processor 82430HX/PIIX3 based system (see figure No. 1). The camera was used as a video input device in a “Video Telephone” configuration, which was bundled as a part of a PC system, and included a PCI Video graphic accelerator card. The system displayed the video input from the camera in a small window on the screen. The application software included a “video mute” function that blocked the camera image from being displayed. To accomplish this function, a bitmap of a closed curtain was superimposed over the actual video display window. A possible application of this feature is to block the video feed for privacy, allowing voice only communication.

It was while executing the video mute function that the telephone application “stopped responding” to user inputs. This anomaly is usually called application “Hang-up”. Notice that in the majority of occasions the actual OS (Windows* 95 Intel* USB Stack Supplement) was still active allowing launch and usage of different applications. To recover video telephone functionality, the system had to be re-initialized. A soft reset was sufficient to recover.

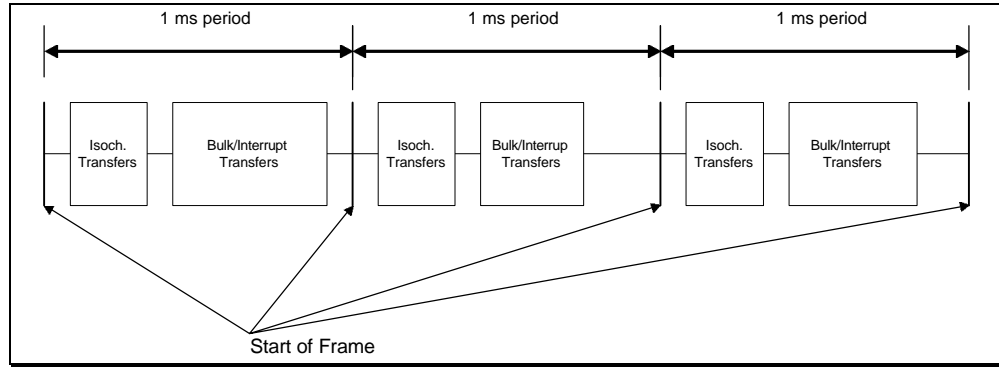
Figure 2: Placement of Isochronous Transactions in USB Schedule Frames

Figure 2 below shows how isochronous transfers fit into a USB schedule. Note they appear first in a 1ms USB frame. Figure 3 below shows in greater detail the structure of a single frame, indicating the region of frame ($n+1$) over which the isochronous transfer from frame n overlaps. Expanding the time used for the isochronous transfer beyond the n th frame’s boundary violates the frame structure, resulting in port babble.

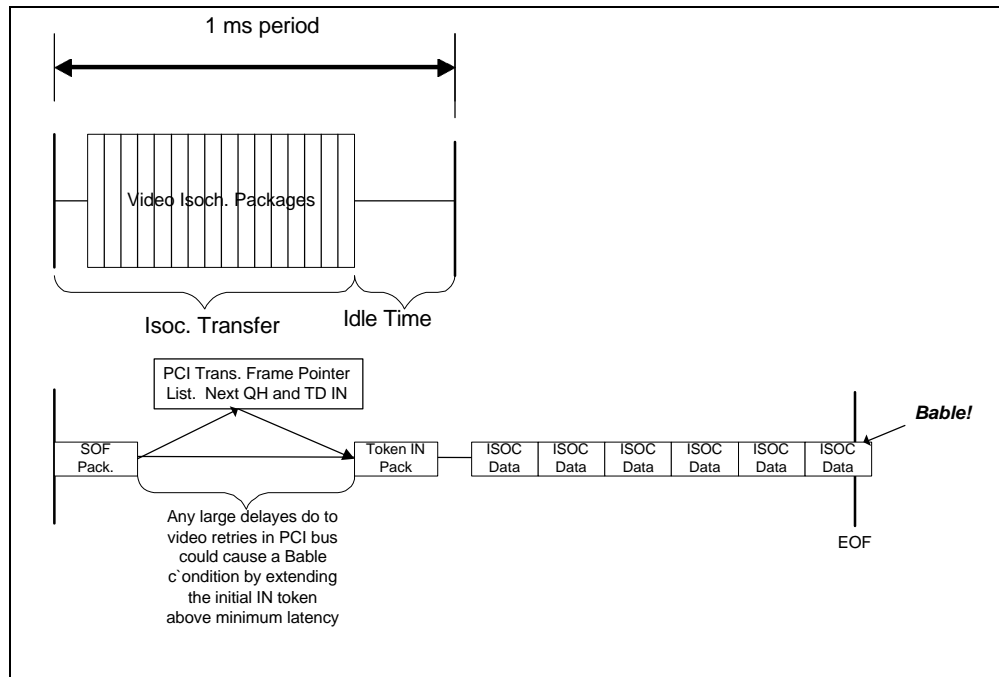
Figure 3: Detail of Isochronous Packet Overlapping into Start of Next Frame

2.- Port “babble” condition. By delaying the IN token from the next transfer a port “Babble” condition occurs, causing the USB port to be automatically disabled, resulting in an application error. FIFO overrun is undesirable; however, port babble causes a system failure, making the anomaly critical.
